## Smoke and Dye-Water Observation Summary

### Western Run Pilot Project - Baltimore Maryland

Sketch No: 100

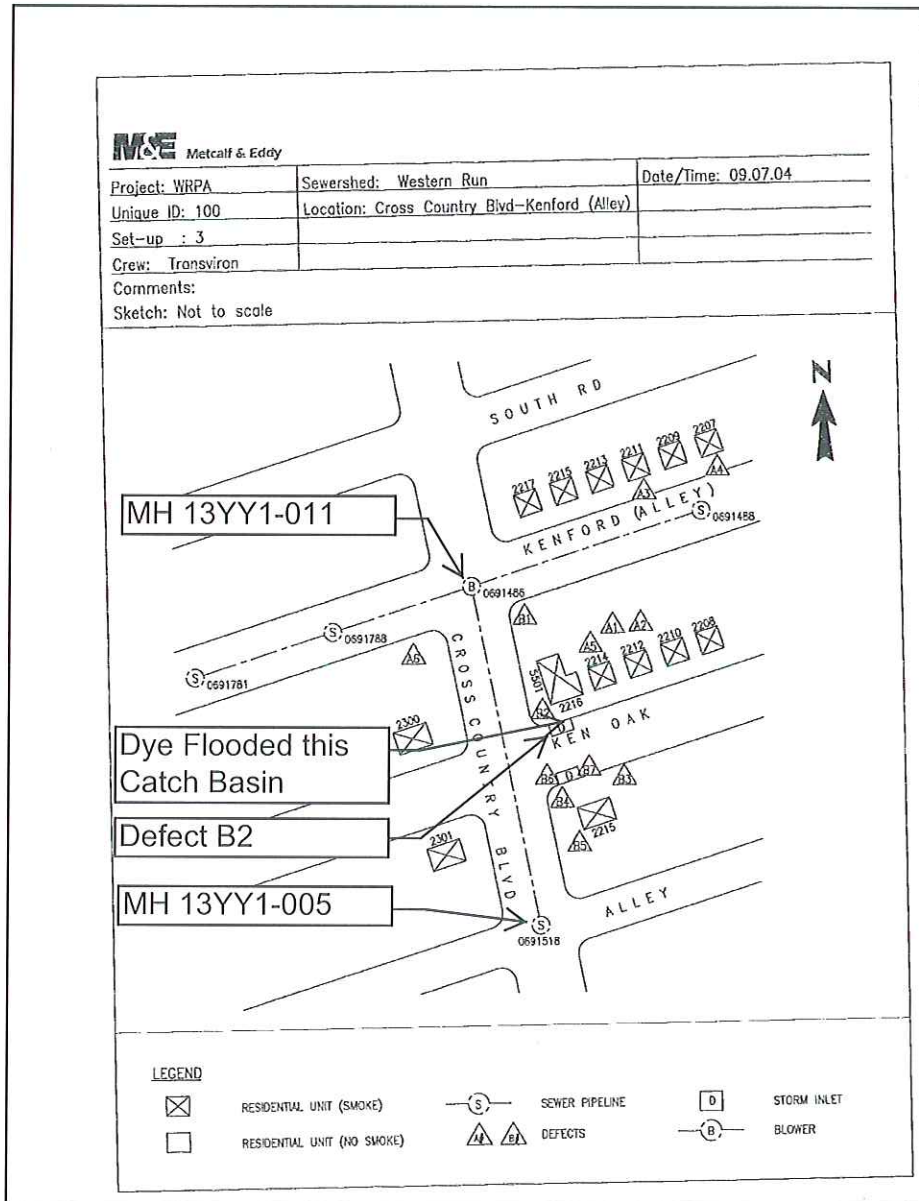
Dye Flooded this  
Catch Basin

Defect B2

Additional Comments: \* THERE IS A SEPRATE STORM LINE THAT  
RUNS DOWN NEXT TO THE SANITARY & SHARES  
M.H. 069148L, DYE UBAINED INTO IT BUT NOT THE  
SANITARY SEWER. RKR
